SUSQUEHANNA RIVER BASIN
UPPER MT. HOLLY DAM
EATON - DIKEMAN OF KNOWLTON BROS.

NDI NO. PA-00583
DER NO. 21-001

CUMBERLAND COUNTY, PENNSYLVANIA
PHASE I INSPECTION REPORT
NATIONAL DAM INSPECTION PROGRAM

JUNE 1981

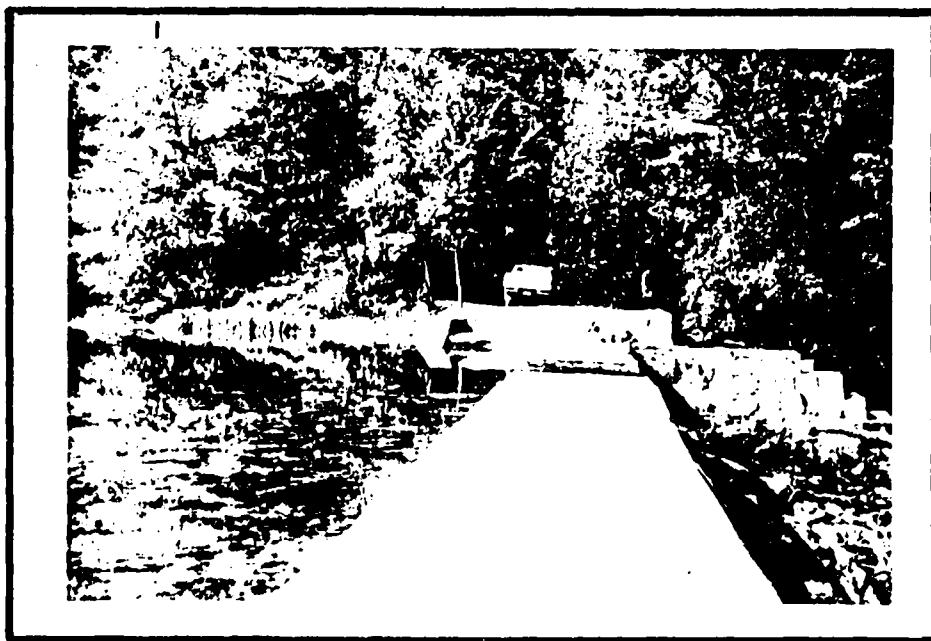
LEFT SPILLWAY ABUTMENT - NO. 3

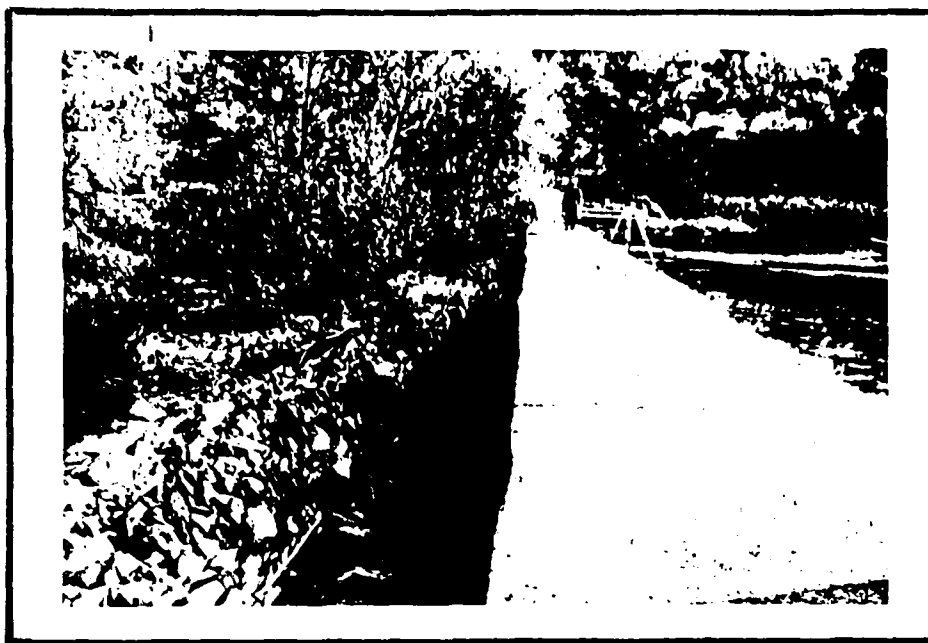
The downstream side of the spillway is protected with hand laid riprap (Photograph No. 4). Several voids have developed in this surface and several trees are growing on this surface. Both conditions could cause further erosion of this protection.

The spillway weir appears to be stable. The gunite surface has cracked and some seepage through the gravity section is occurring. To prevent future erosion, the trees in the downstream slope should be removed and the voids should be filled.

DOWNSTREAM ROCK PROTECTION OF SPILLWAY - NO. 4

1
After this clearing, the embankment should be inspected for seepage and signs of instability. The embankment should be made level and should be protected against erosion with a good grass mat. The riprap at the downstream side of the spillway should be repaired.✓

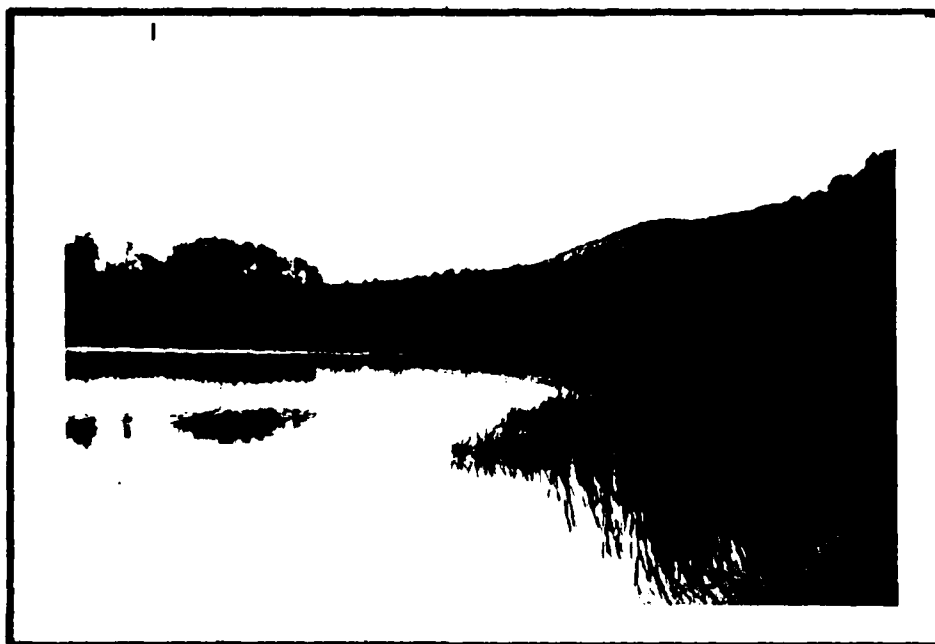
RESERVOIR OVERVIEW - NO. 11
NOTE: WEED GROWTH IN RESERVOIR
